Project:	13 East Franklin Street, Richmond, Virginia		
Client:	Patrick Ford	Inspected by:	Charles R. Field, P.E.
Date:	May 6, 2022	Time:	10:00 am
Weather:	Overcast	Temperature Range:	70's

The structure located at 13 East Franklin Street, in Richmond, Virginia, is a two story, detached, professional office building. The building was constructed in 1847, using construction methods typical of the time. The 6,072 square foot building faces on a 0.015-acre lot.

13 East Franklin Street, Richmond, Virginia
May 6, 2022

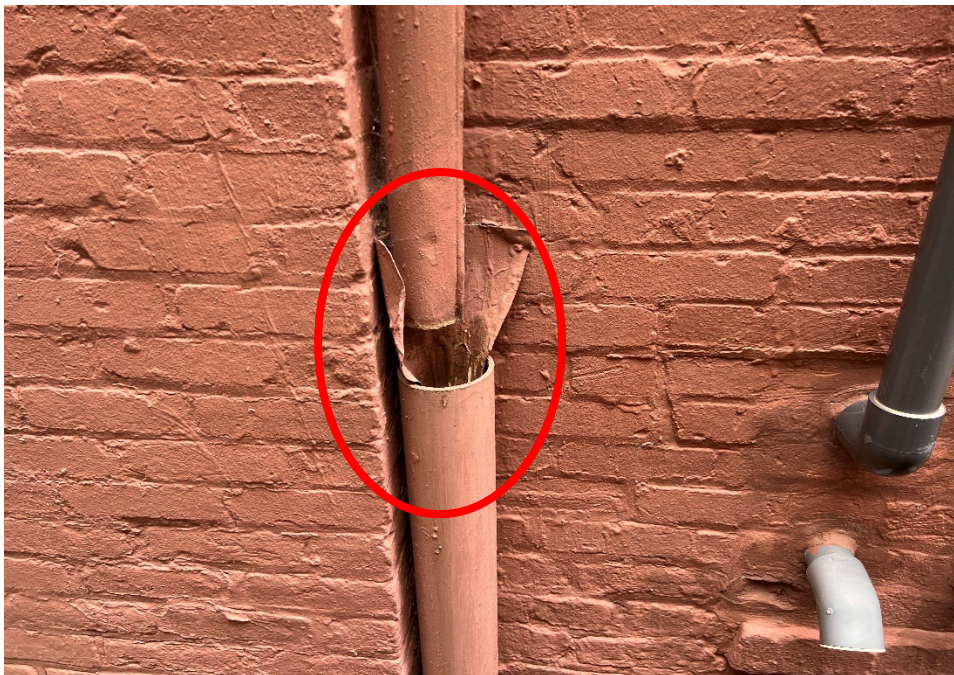
Exterior inspection of the structure finds that the building a working gutter system installed. Several downspouts discharge in the rear of the building, directly into the city's storm water system. One downspout appears to overflow the connection on a regular basis, as all the earth and mortar between the bricks used as pavers nearby is missing.

Several of the gutter downspouts discharge into the city's stormwater system.

Have a licensed plumbing contractor with optical scoping capabilities run cameras down all the drain lines around the building, including floor drains and gutter downspout connections. Ensure that all of the lines are properly functioning and free of debris. Local companies such as *Pipe Vision* could also accomplish this task. If the lines are not functioning consult with a plumbing contractor about possible repair.

If the lines appear to be functioning properly then make solid connections from the gutter downspouts and the HVAC condensate lines to the stormwater lines, so that water is not allowed to escape the system,

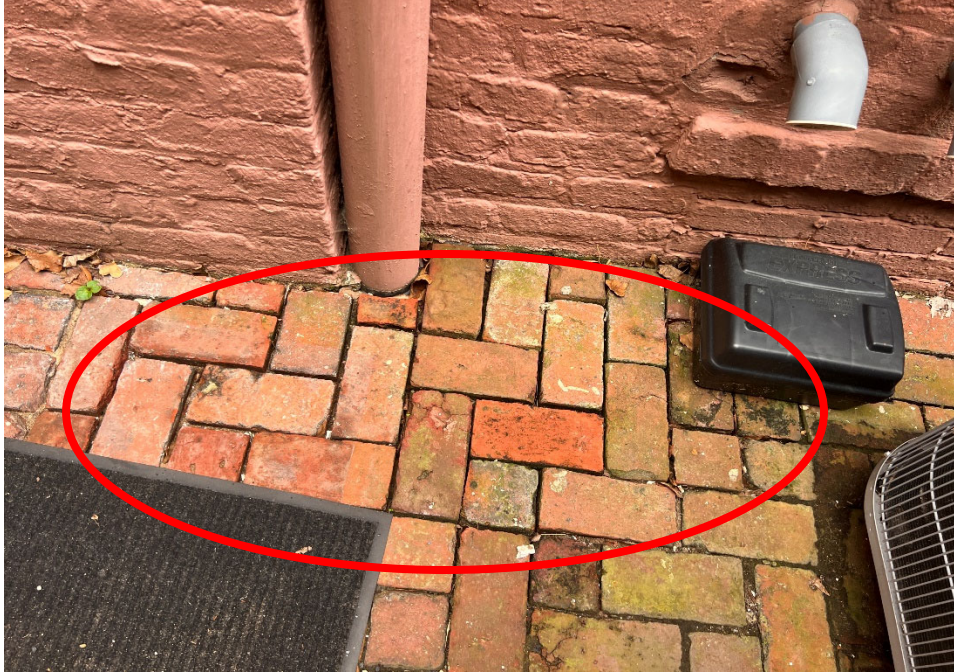
The buildings gutter downspouts are discharging directly into the city's stormwater system. If these buried pipes are properly functioning then it is the best way to remove water from around the building. But these lines are likely very old and could be clogged, damaged, or have completely collapsed, allowing water to back up in the system. The washed out area around one downspout connection suggest that water routinely overflows here.

The lack of mortar or earth around the base of one downspout suggest that water overflows in the area.

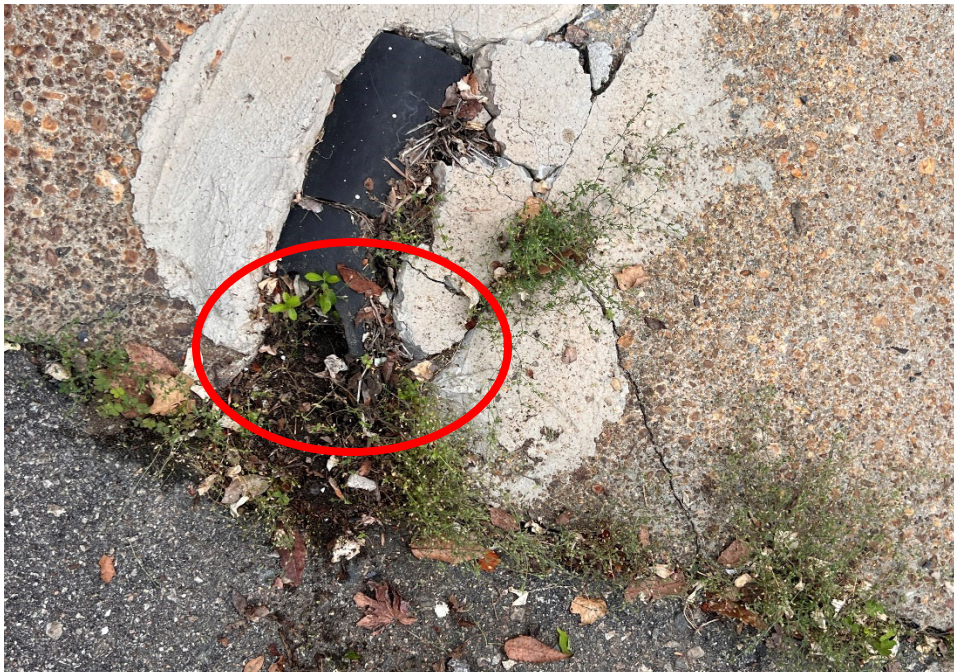
One downspout is attached to the neighboring building and is routed to the rear alley. This line appears clogged with debris.

The downspout that discharge into the alley is clogged with dirt and debris. This likely slows the amount of water that can exit the line, potentially causing the line to back up and overflow the system.

This downspout is routed to the rear alley, but it appears clogged with debris.

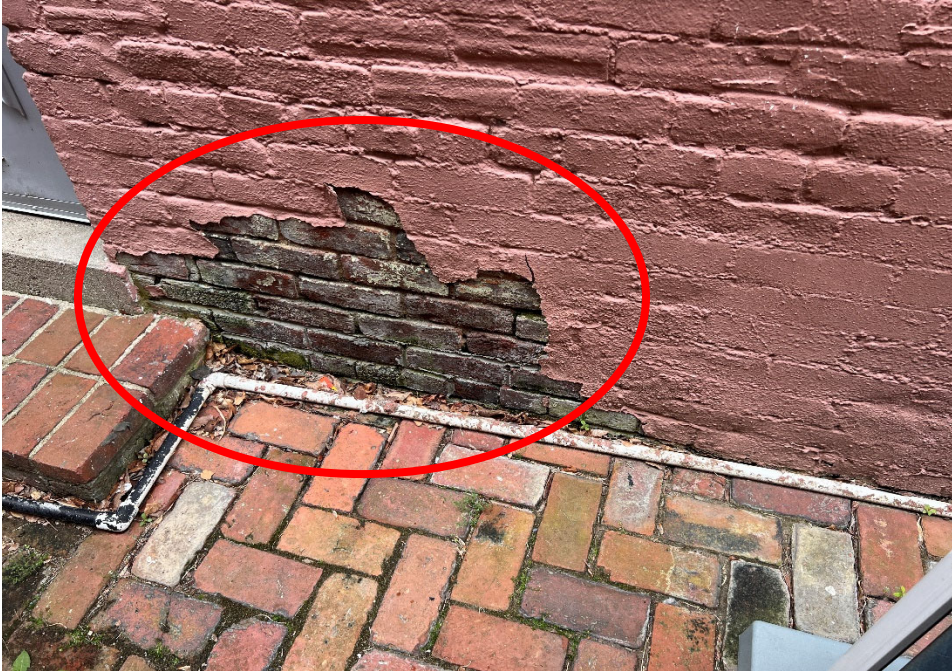
The building has been painted and sealed in the past. Portions of the paint, especially near ground level, have spalled and are coming off the brickwork.

It appears that water is finding its way between the courses of brick work that make up the exterior walls. As water travels down inside the wall, it makes its way to the ground level, where the porous bricks absorb the water, The peeling paint around the building at ground level suggests that water is present

When the building was sealed and painted it stopped the building from being able to properly “breathe”. Since water is present inside the walls and it can’t escape, it creates a moldy smell and damp conditions. This condition is exasperated in the winter months. In the summer the buildings HVAC units work efficiently to remove water from the air and deposit it outside the building through the condensate lines. But in the winter months the HVAC units do not remove water, and the musty damp conditions return.

Paint spalling and flaking off near the earth line suggest that water may be present inside the wall.

If there was an unlimited renovation budget we would recommend removing the paint and sealer so that the building could breathe again. But this could be a costly endeavor. The installation of a in-line dehumidification system should be considered. A whole building dehumidifier would accomplish the same goal, likely at a significantly lower cost. Have a qualified HVAC contractor install the system. Ensure that any discharge lines from the dehumidification system are routed into the drainage system.

Have a qualified roofing contractor find and seal any places that water may be entering the building between the brickwork. Pay special attention to the exterior parapets, as this is a common culprit for water intrusion.

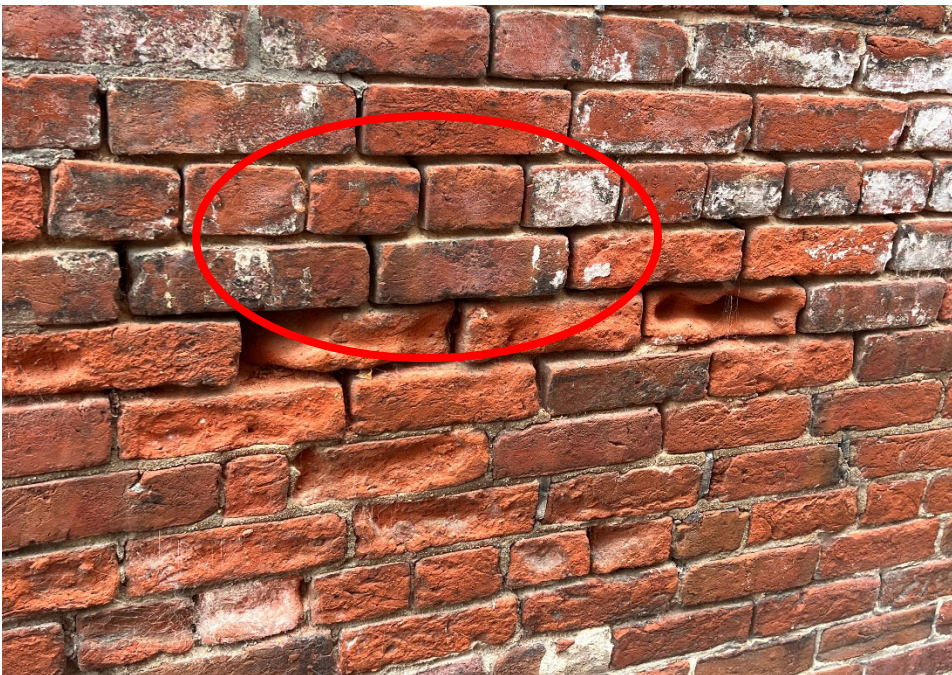
Several areas around the building show signs of water cascading down the brick exterior and washing away the mortar between the brickwork.

Mortar is deteriorated or missing in several areas around the building.

Have a qualified masonry contractor familiar with historic brick work repoint any areas around the building as deemed necessary.

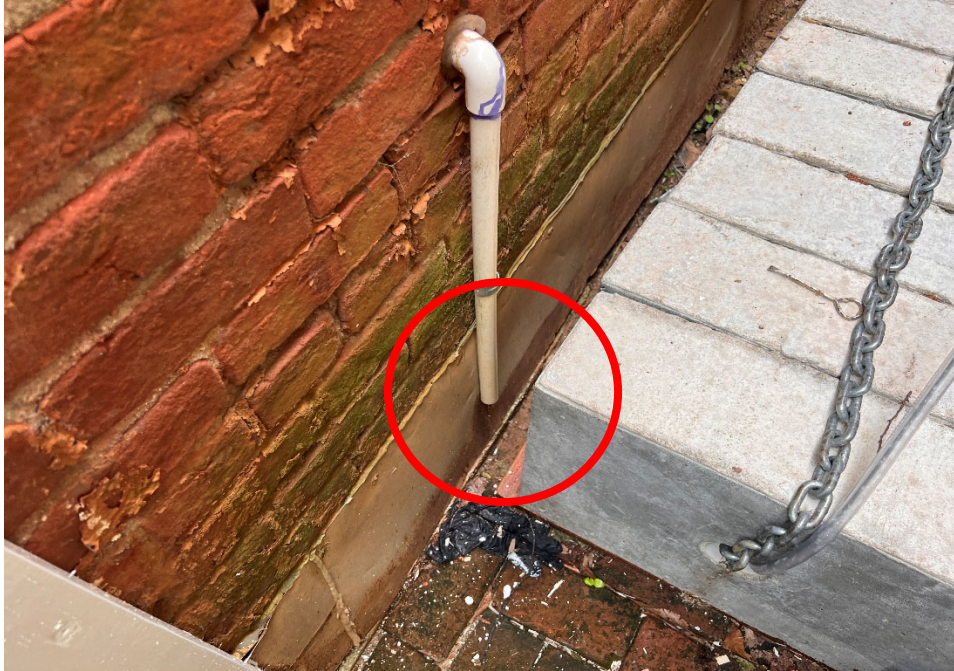
Several HVAC condensate lines are seen discharging in the area between the two buildings.

HVAC condensate lines should never be allowed to discharge against a buildings foundation. An HVAC condensate line can discharge a surprising amount of water. During hot, humid days as much as 60 gallons of water can be generated per line. And this water comes out drip by drip, which is the perfect way to fully saturate the earth over time. This building has several different condensate lines, some of which discharge at the base of the buildings foundation.

Several HVAC condensate lines are discharging at the base of the buildings foundation.

If possible, work with the neighbors on both sides of the building to ensure water is removed. On the right side of the building connect the neighbors downspout, along with the HVAC condensate lines and run them toward the street.

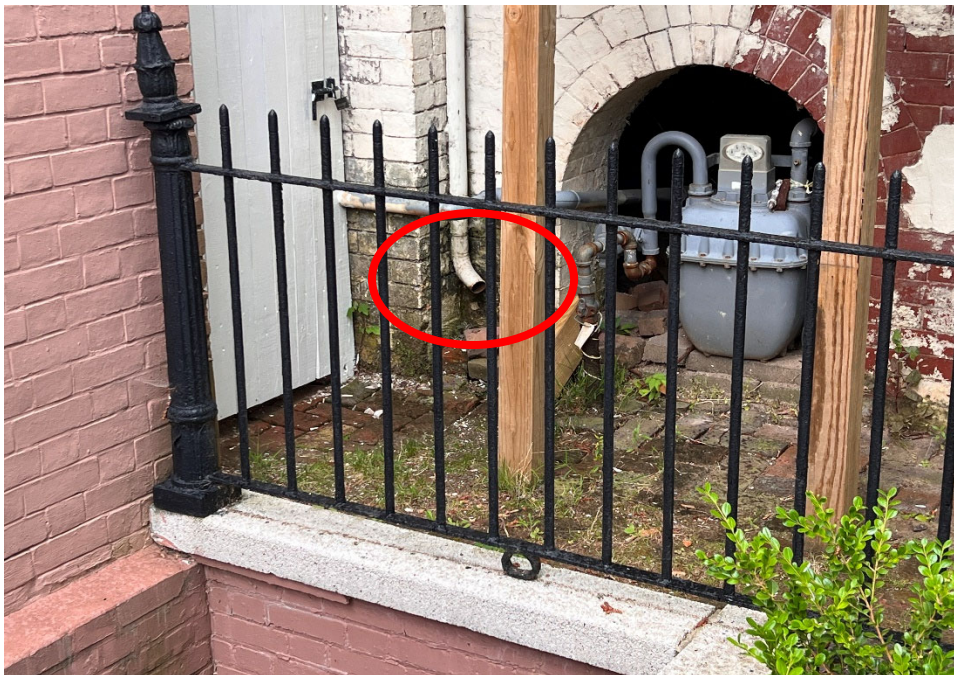
The neighboring building on the right side has a gutter downspout that is discharging close to the retaining wall that forms the basement entrance and patio area. The retaining wall has been pushed inward.

The neighbors gutter downspout is discharging close to the building and the nearby retaining wall.

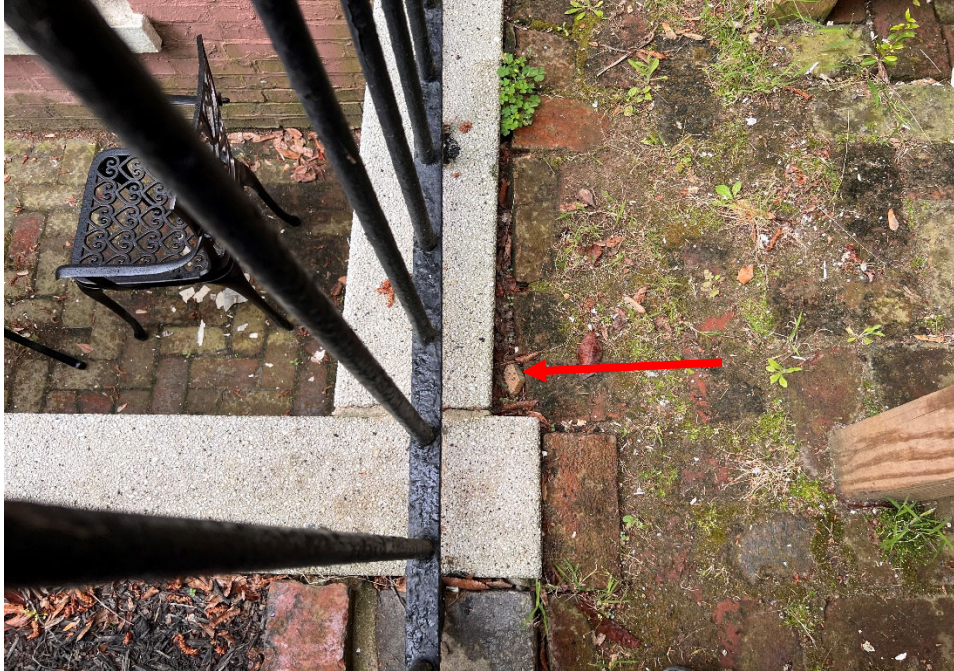
Water from the neighbors gutter downspout is saturating the earth and pushing the retaining wall over. Dry earth does not move and will sit peacefully behind a retaining wall. But wet earth pushes extremely hard against the wall. The wall has already been moved by a few inches. If allowed to continue, eventually the wet earth will push the wall over.

The retaining wall has been pushed inward several inches.

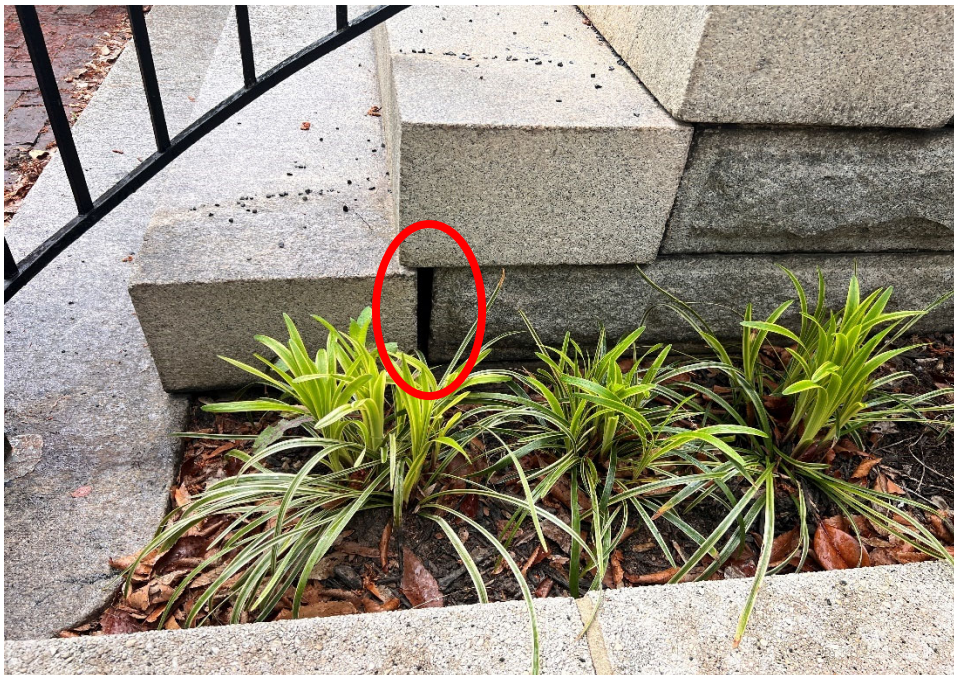
In front of the building wet conditions are present. Voids are seen developing between the large pieces of granite that form the front staircase. When the granite pieces were originally laid, it is doubtful that these gaps existed.

Wet conditions are present in front of the building. Water is arriving here from various sources, including the covered front porch, which has no gutter system installed. The wet earth is allowing the main staircase to gradually sink and separate. Highly skilled masons originally laid these steps, and it is doubtful that these gaps existed upon installation.

Gaps and voids have formed on the granite staircase.

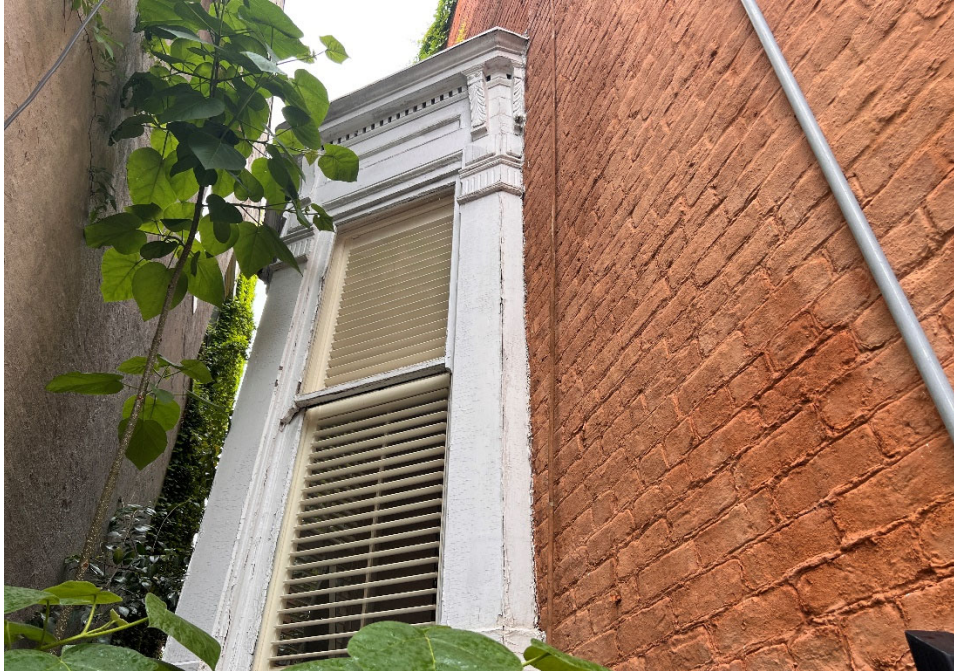
On the left side of the building vegetation is seen growing on the masonry exterior.

The owners have expressed a desire to remove the bay window on the left front of the building and replace it with a series of windows.

The vegetation growing on the right side of the building exasperates the moisture issue by not allowing sun to reach the building. The vegetation allows the area to remain damp.

Since the bay window can be easily seen from the public right of way, it falls under the purview of Richmond’s Commission of Architectural Review. It’s extremely doubtful that they would allow the removal of the historic bay window on the left side of the building. While the owners state that the bay window was not original to the structure, it has been in place long enough for Richmond’s C.A.R. to claim it is historic and should be retained.

The owners would like to remove this bay window. Vegetation grows on the masonry behind the window.

Remove the vegetation that is growing on the building.

While it's doubtful that the Commission of Architectural Review would allow the removal of the window, it could be worth a phone call to the commission to inquire about it's removal. If the commission indicates that they might be open to the idea of removal, then prepare a set of plans showing the commission what would be inserted into the new opening.

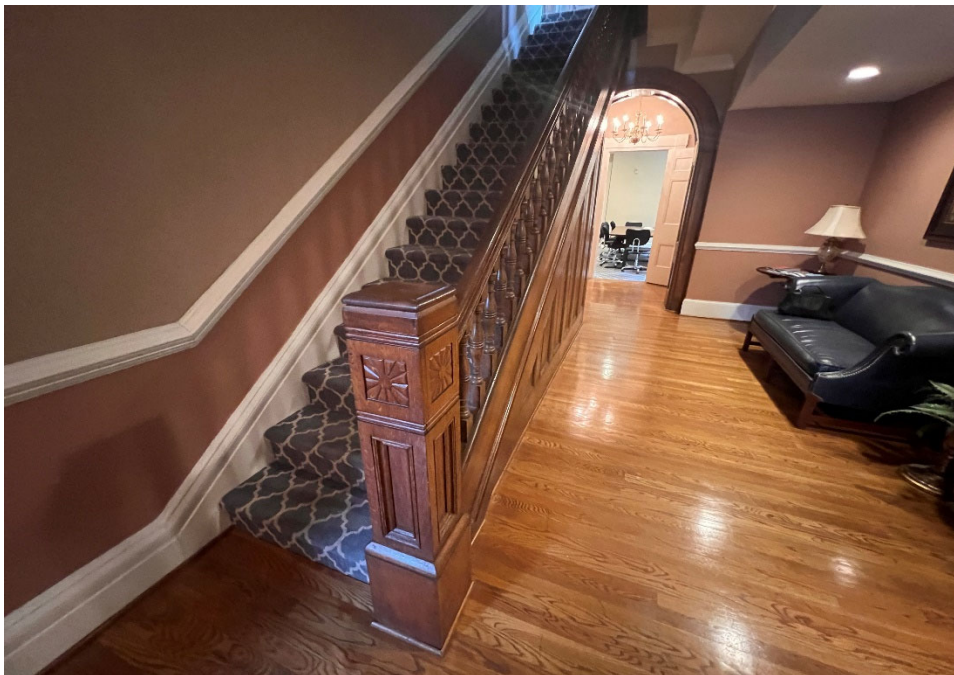
While some typical settlement cracks were observed inside the building, we found nothing that would indicate a serious concern. The slightly sloping floors around the staircase are typical of this type of construction. The staircase opening is formed to apply the load from several joist to one header. Over time some of the lumber has deflected under the wight, but this is not a serious structural concern.

The structure around the main staircase has slightly deflected.

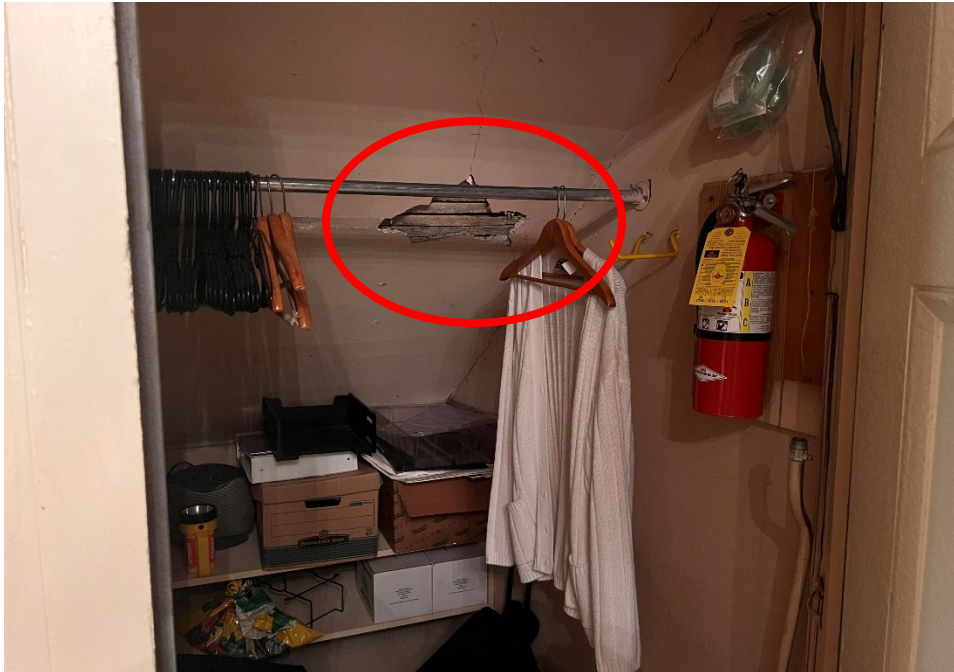
Interior inspection of the building found several routine settlement cracks in plaster wall panels. None of the cracks were deemed serious structural concerns. In one area under the central staircase a large portion of the plaster has deteriorated and fallen off the wooden lathe.

The plaster that has fallen in the closet under the staircase should be covered with new drywall. It’s hard to find a qualified plaster repair contractor, and the plaster itself may contain traces of asbestos. Simply installing new drywall over the existing plaster will encapsulate the area, and will be a cheaper alternative to plaster repair.

Plaster has fallen off the lathe work in the closet under the stairs.

Have a drywall contractor install new drywall over top of the existing plaster in the closet under the staircase.
